A STUDY OF THE PHYSICAL AND CHEMICAL DAMAGE ON REVERSE OSMOSIS MEMBRANES DETECTED BY AUTOPSIES

Authors: Nuria Peña García^a, Fernando del Vigo^a
Stephen Chesters^b, Matthew Armstrong^b, Rachel Wilson^b, Max Fazel^b

Abstract

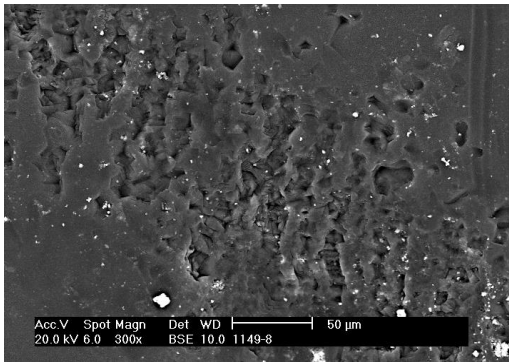
Abrasion marks from fouling (SEM image)

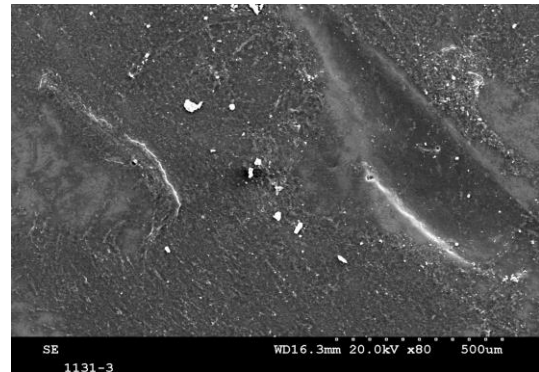
Marks from spacer (SEM image)

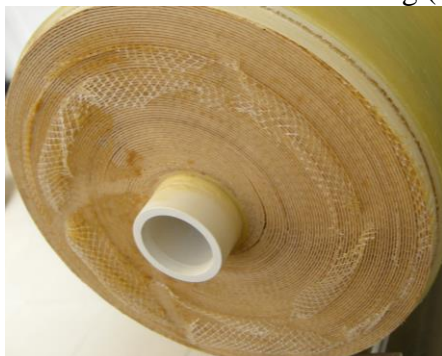
Spacer protrusion

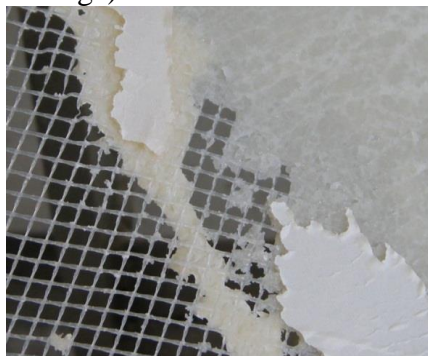
Polyamide layer damages due to fouling

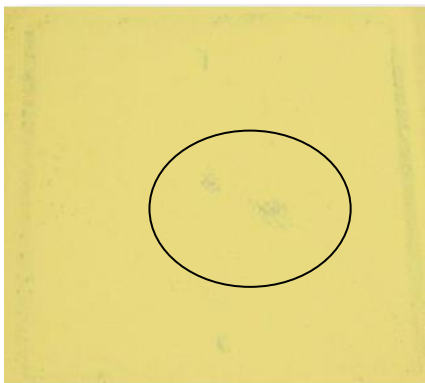
For the demonstration of these conclusions, we did some tests on our labs and, as next photographs show we verified that even with a severe chemical damage, methylene blue test is not as positive as with a severe physical damage. Therefore, this test seems to be more sensitive to physical than to chemical damage.

Photograph 1.- Methylene blue test on a membrane with a **severe chemical damage**

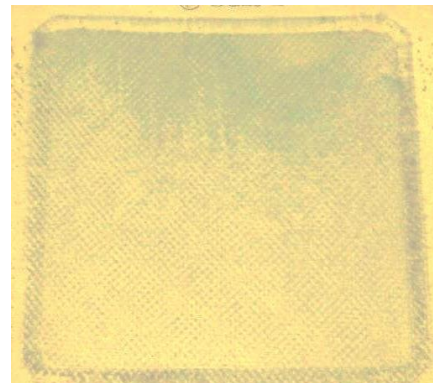
Photograph 2.- Methylene blue test on a membrane with a **severe physical damage**

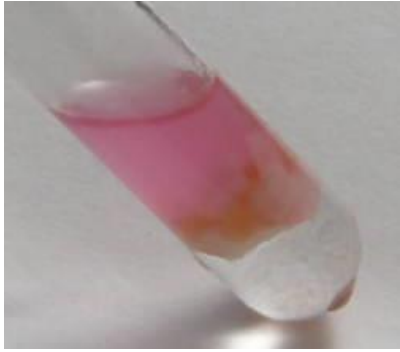
Example of a positive Fujiwara test

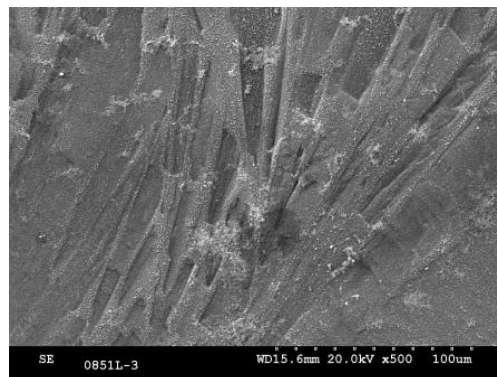
Severe physical damage

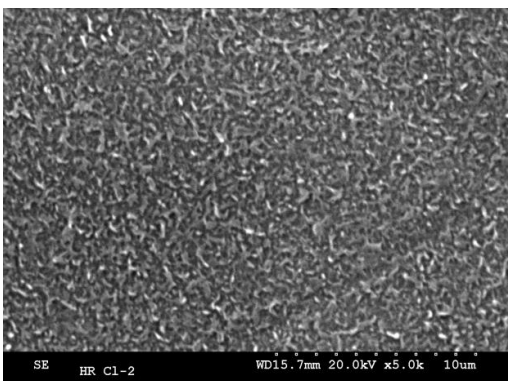
Mild chemical damage

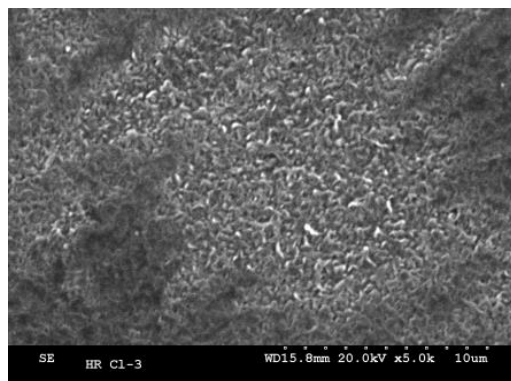
Severe chemical damage

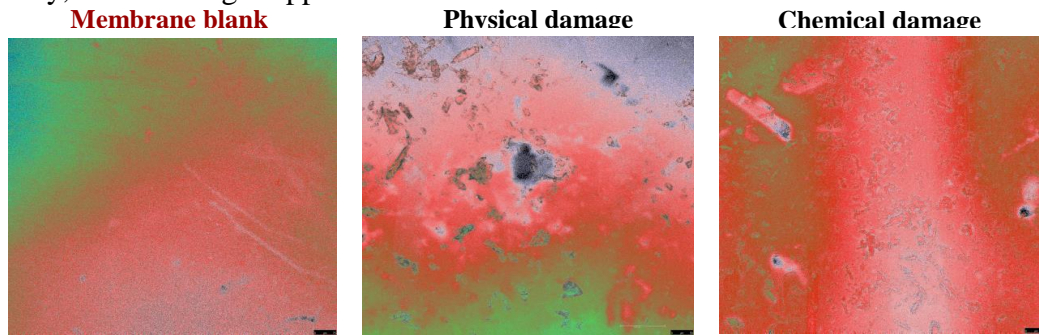
Although this microscopy is more similar to an optical microscope and it doesn't allow to reach very high magnifications as SEM, these photographs show how it could help to distinguish physical damages in an easiest way, since damages appear as dark holes on the surface.

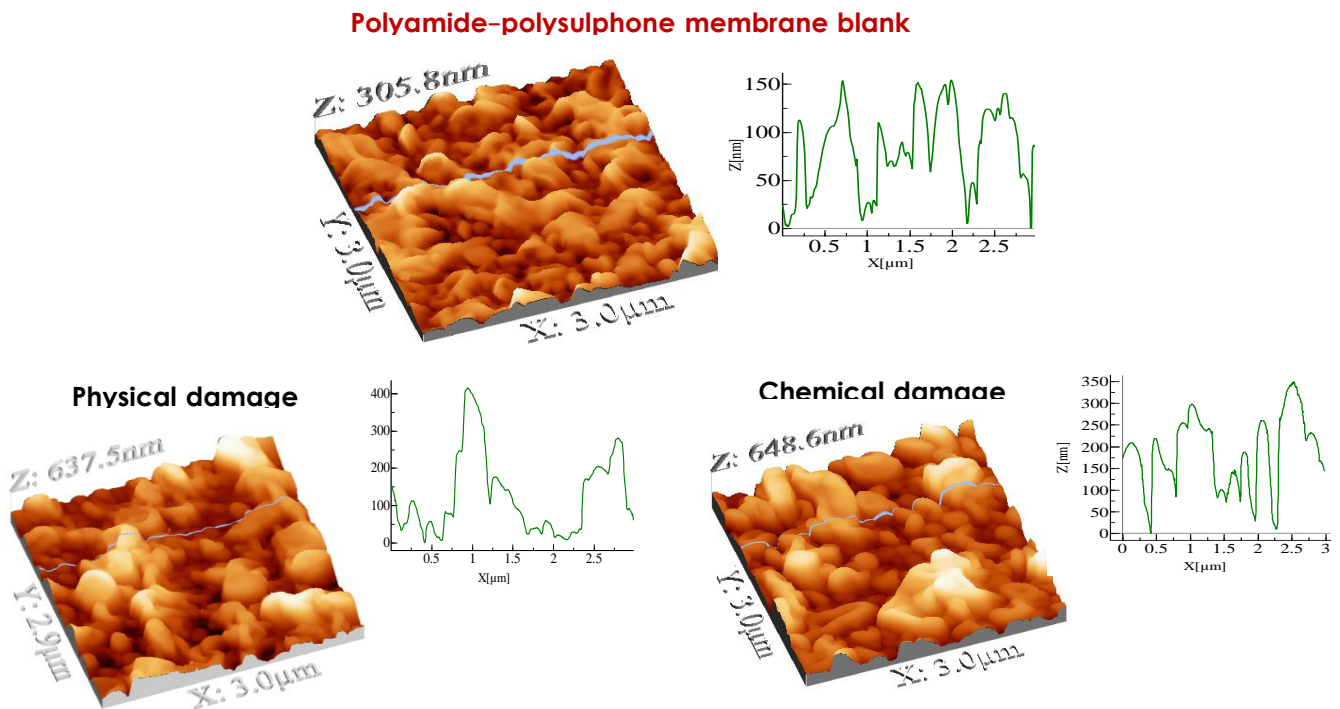
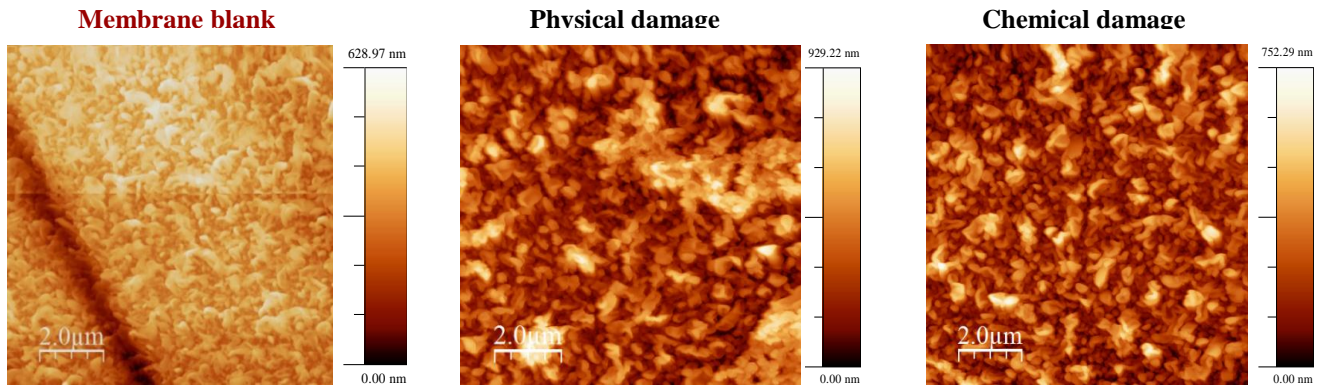
Figure 15. Images and topography of membrane with physical and chemical damage

If we check the three dimensional images of a membrane blank and damaged membranes and its relieves, we can observe that when the damage is physical, it seems that the difference between the maximum and valleys on the membrane are much higher that on the membrane blank, which looks more smooth. On the other side, the membrane with chemical damage has a relief more similar to the membrane blank, but the distance between the valleys and maximums is much higher and wide on the membrane chemically damaged.
