A STUDY OF THE PHYSICAL AND CHEMICAL DAMAGE ON REVERSE OSMOSIS MEMBRANES DETECTED BY AUTOPSIES

Authors: Nuria Peña García^a, Fernando del Vigo^a
Stephen Chesters^b, Matthew Armstrong^b, Rachel Wilson^b, Max Fazel^b

Abstract

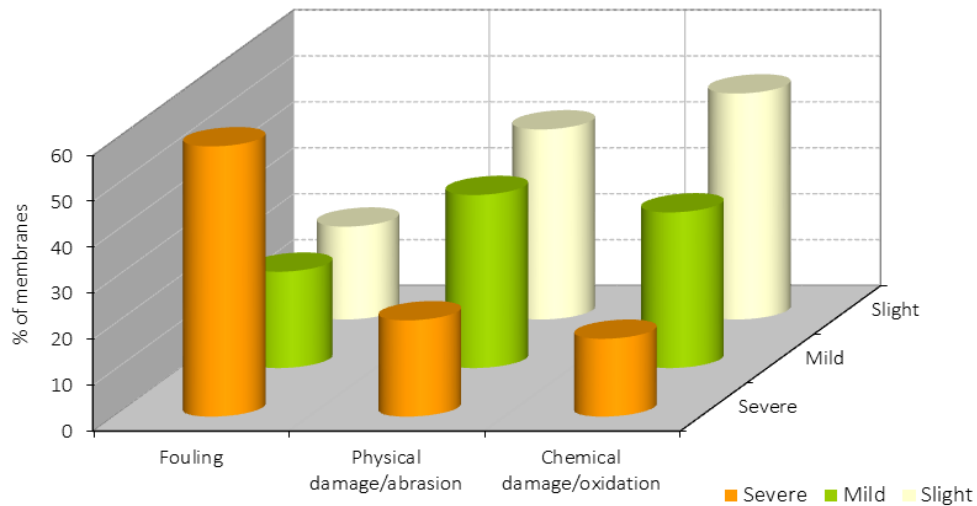
Figure 1.- Main membrane failures detected from membrane autopsies (n=600)

Figure 1 shows the data obtained from 600 autopsied membranes, and demonstrates again that the main causes of failure on RO membranes performance is fouling. As we demonstrated before by the study of fouling impact on RO membranes [1] the main and worse consequence of the presence of fouling on the membrane surface is the damage that polyamide material may suffer. As figure 1 demonstrates, although it is more common to find mild and slight physical damages on membranes surface it is very important to know the extent of membrane damage in order to determinate if membrane rejection capabilities can be recovered. On the other side, chemical damage is detected also as mild and slight extent on a similar percentage of membranes and it is important to distinguish both phenomena in order to get an accurate diagnostic of the RO system failure.

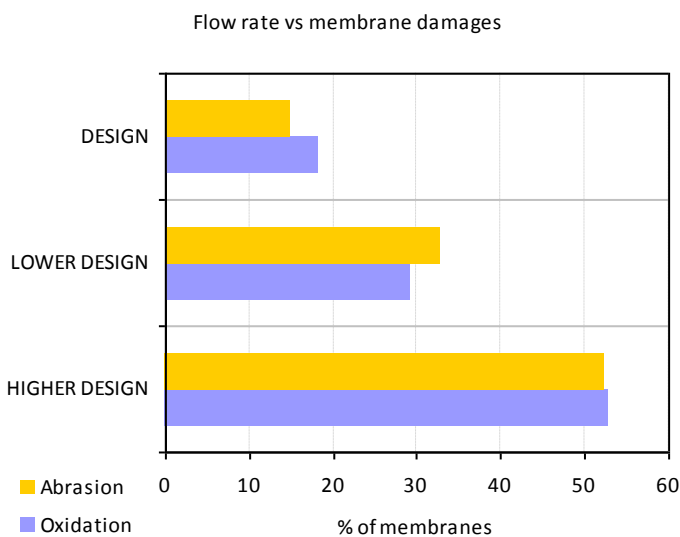
Figure 2.- Permeate flow rate from damaged membranes

One of the most clear signs of damages on an RO membrane is the lack of salt rejection capabilities and very often an increase on permeate flow rate. Next figures 2 and 3 show the performance of membranes with mild and severe damages depending on the kind of damage detected during autopsies.

As expected, these figures demonstrate that, in most of the studied membranes, flow rate was higher than design and salt rejection was lower than expected for a membrane in good conditions.

But the conclusion that should be remarked from these graphs is that, despite the damage observed on some of the membranes, there is around a 30% of membranes giving a flow rate lower than design and more than a 10% of membranes that gave a flux similar to the reference values established by manufactures. This behaviour is mainly due to the presence of fouling and therefore in many cases it is not possible to detect membrane damages on site after fouling is removed.

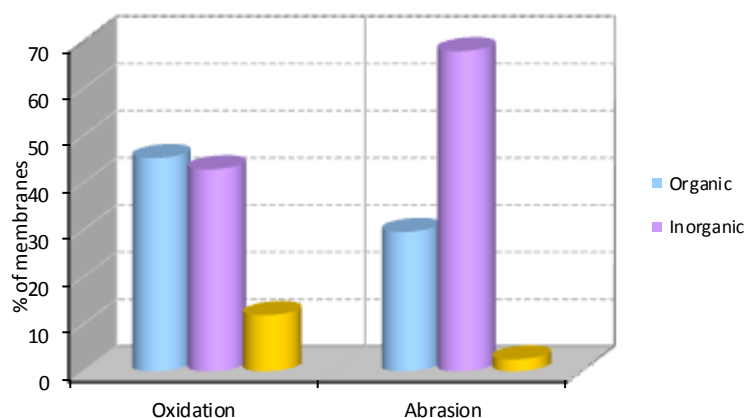
Figure 4.- Damages depending on the nature of fouling

As figure 4 shows, when just the main nature of the fouling is considered, the number of membranes with chemical damages is quite similar for organic and inorganic fouling. However, when physical damages are considered, they are more common when the fouling is mainly inorganic.

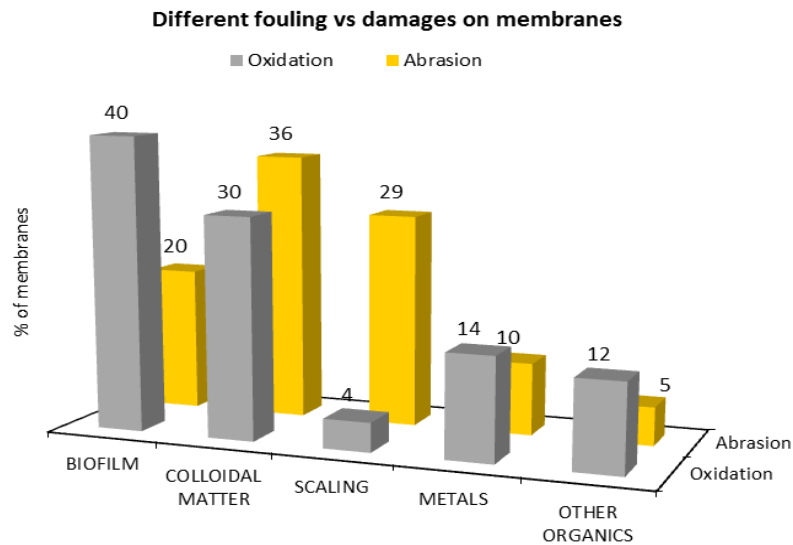
Figure 5.- Damages depending on the composition of fouling

As it can be observed on this figure, when the main damage is physical, the main percentage of membranes was fouled with colloidal matter and scaling.

On the other side, although in most of the cases presence of fouling produces physical damage, chemical damage is observed also on fouled membranes. Figure 5 shows how the most common fouling observed on chemically damaged membranes is biofilm. The use of oxidant agents is broadly used for disinfection of the water before it comes into the membranes, and so it is easier that these systems are in a higher risk of oxidation. By the way, this figure demonstrates that oxidation process may occur in presence of any kind of fouling, although the lowest percentage of chemically damaged membranes was found on scaled surfaces.

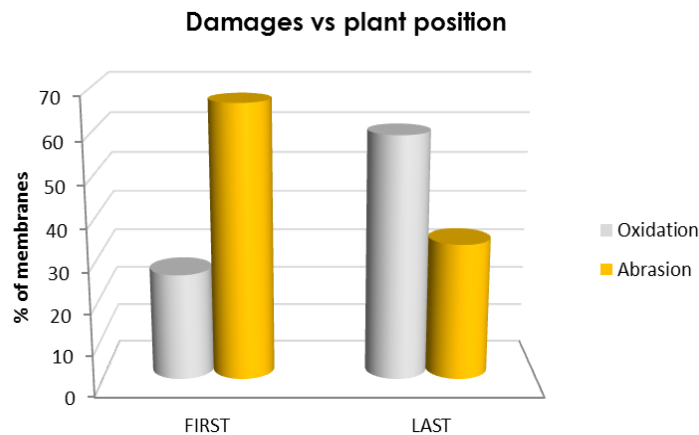
Figure 6.- Damages detected on autopsied membranes depending on site position

Quite related to the composition of the fouling, it is interesting to consider the position of the membranes and the damages observed on them (figure 6). As this figure shows, although both physical and chemical damages can be detected on all the studied positions, abrasion is more common on first positions and oxidation processes on last positions.

The most common types of fouling that are detected on membranes (biofilms and colloidal matter) are commonly related to first positions and, thus it is reasonable to find a higher percentage of damages on first positions. Concerning chemical damages, the first contact of any chemical is with the first position, but once again if we consider that the most common fouling are mostly found on the first positions, the chemicals would damage in a less extent the membranes with less presence of fouling.

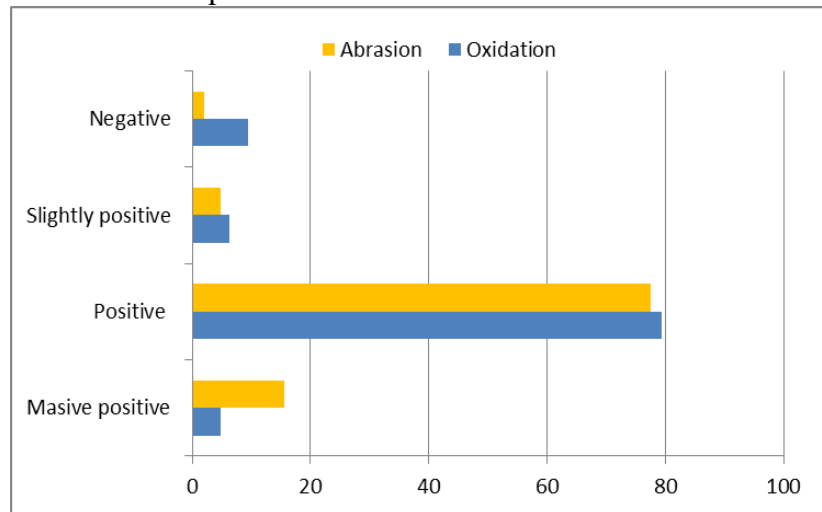
Figure 8.- Methylene blue tests on membrane autopsies.

This test is based on the passage of a high molecular weight compound through the polyamide layer. When presence of this compound is detected on the permeate side of the membrane, it means that the polyamide layer is damaged. As figure 8 shows, methylene blue test was positive for almost the 80% of the membranes with chemical and physical damage. As this figure shows, membranes with oxidation show a higher percentage of membranes with a negative answer to the test and membranes with abrasion a higher percentage with a massive positive.

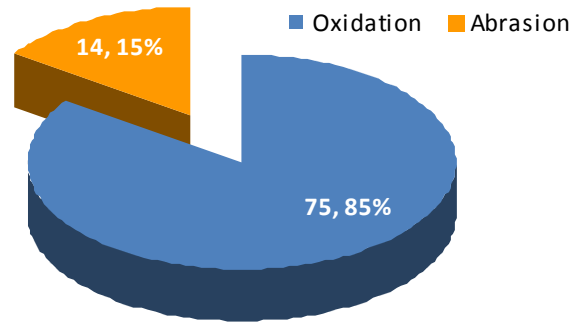
Figure 8.- Positive Fujiwara tests on membrane autopsies

FJ test detects significant levels of polyhalogen compounds so it will detect if the membrane is significantly oxidised. This is a colorimetric test in which a pink colour in the analytical solution, indicates organically bound halogens. Figure 8 shows the percentage of membranes with a positive Fujiwara test on membranes with oxidation and abrasion as main failures detected. As expected, Fujiwara test was positive on the 76 % of the membranes with clear signs of oxidation and on a 14% on membranes that showed also a relevant physical damage.

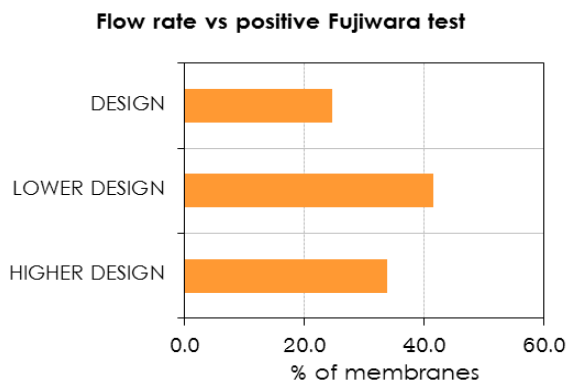
Figure 9.- Performance of membranes with positive Fujiwara test – flow rate

Considering the performance of the membranes with a positive Fujiwara test, next figures 9 and 10 show how in more than the 60% of the membranes flow rate was lower or equal than design. On the other side, even with a positive answer on this test, the 20% of the membranes gave a good salt rejection. These results verify that Fujiwara test indicates that the membrane has been in contact to halogen, but does not confirm damage by oxidation.

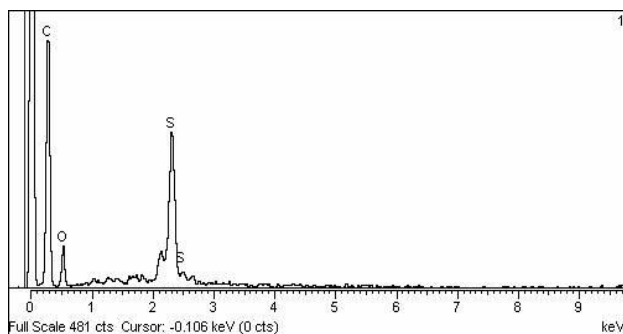
EDX spectrum 1. Blank membrane

Concerning chemical damages, it is very difficult to detect them by this technique. Next images show the differences between a blank membrane and membranes with relevant physical damage and mild and severe chemical damage. As it can be observed, it is only possible to detect accurately physical damages by this technique, since even when chemical damage is very relevant, it wouldn't be possible to distinguish a damage that a fouling. On the EDX analyses of these examples (spectra 1 to 3) we could detect traces of the oxidant agent (chlorine), but in a real sample it would be impossible to verify if this chlorine could come from hypochlorite or from rests of sodium chloride, for example.

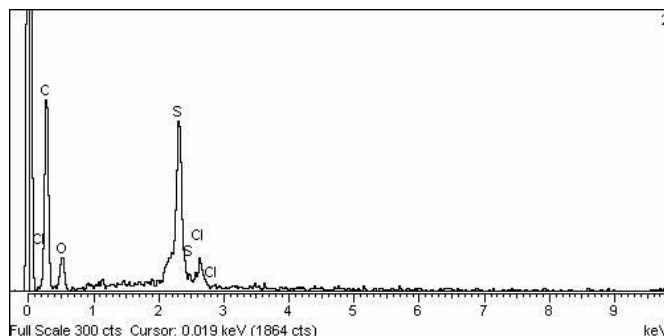
EDX spectrum 3. Severe chemical damage

The detection of the oxidant agent would get more complicated on sea water samples, where the real oxidant agent is bromine, which is more difficult to detect by this technique. On those cases, it would be necessary to check the membrane by X-RAY FLUORESCENCE, for example which is much more sensitive.

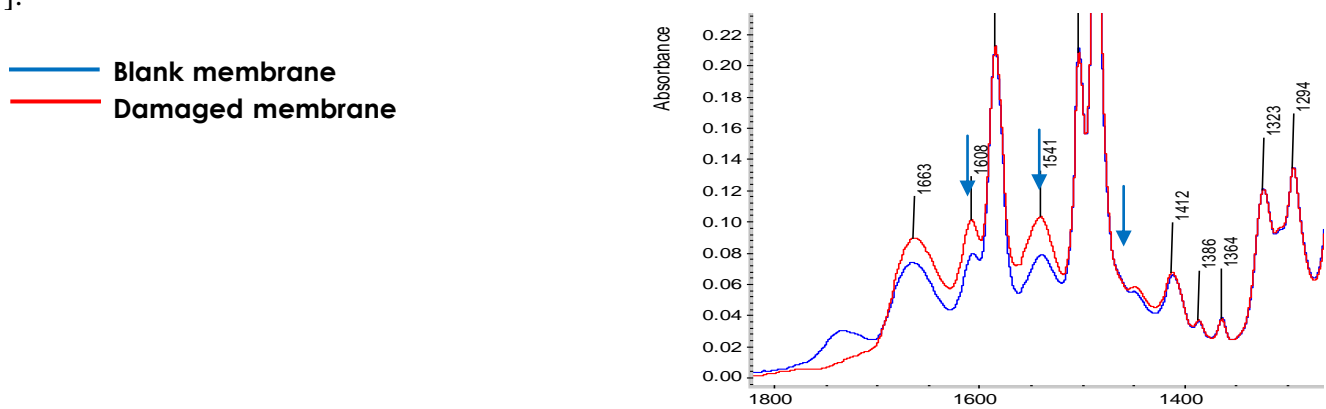
Figure 11. Severe Physical damage

Then, by this technique we can be check polyamide layer bands and to check if there are any structural changes on it [6]. Comparing membranes with different damages to a membrane blank spectrum (see figures 11 to 13) it can be observed that there are no relevant changes on membranes with physical damages. On membranes with chemical damages, some slight changes can be observed on membranes with mild damages, but when oxidation processes are severe, these bands can even disappear.

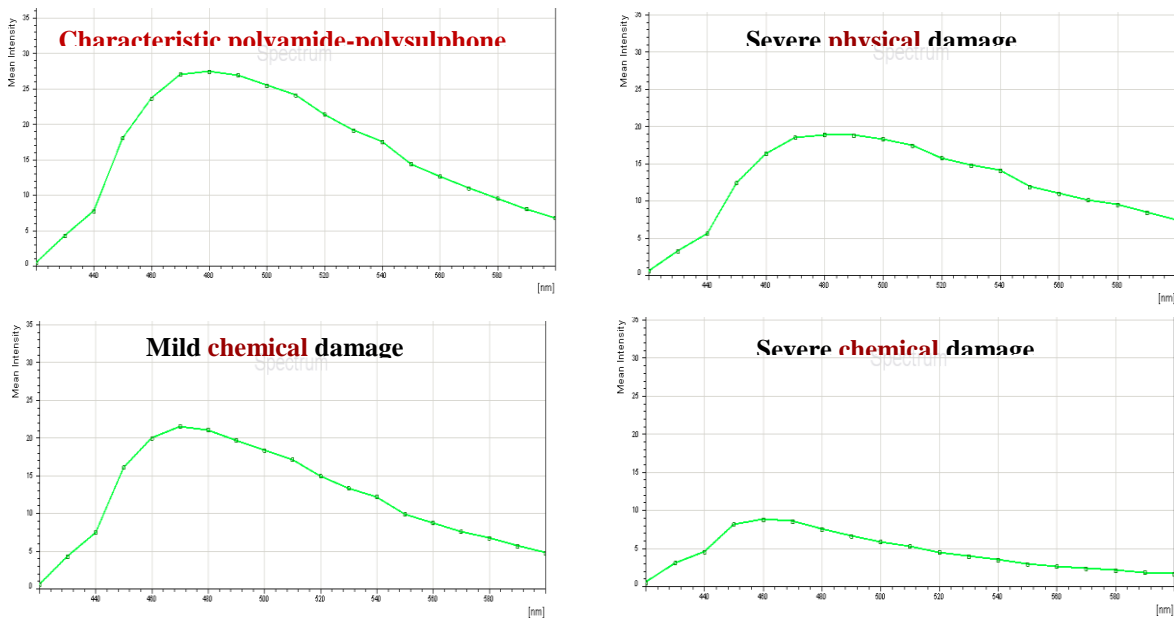
Figure 14. Emission spectra from different membrane damages obtained with a confocal microscope

Therefore, if we compare the spectra obtained with different laser sources on the study of one membrane blank and damaged membranes (figure 14), we can observe a decrease on the intensity of the spectrum maximum with the damages. Although the spectra changes with all the damages studied, this technique seems to be more sensitive to chemical than to physical damages.

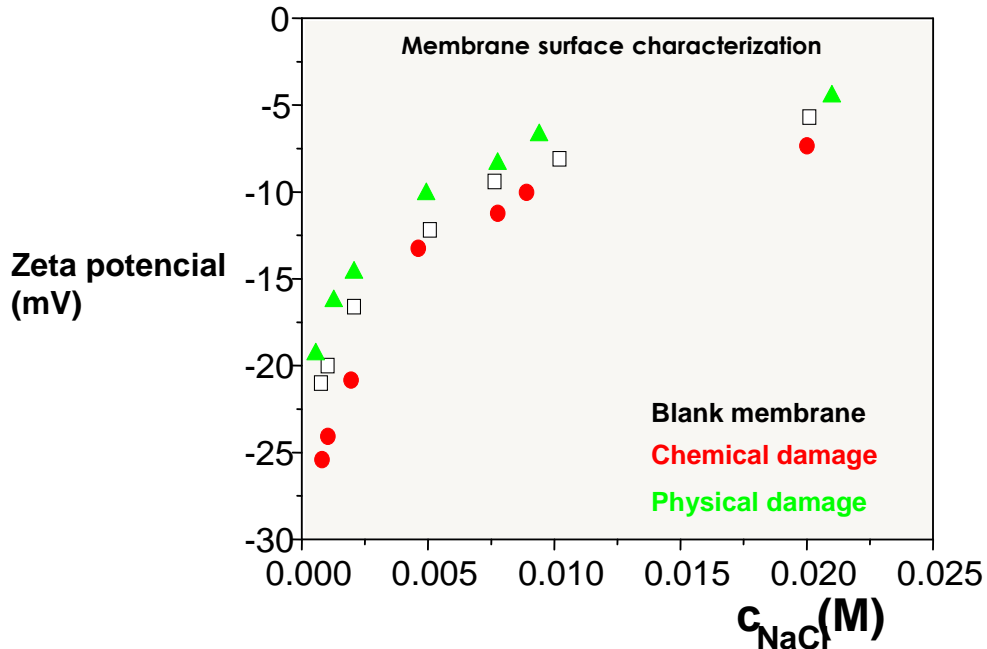
Figure 16. Zeta potential values obtained from membranes with physical and chemical damages

Next figure 16 represents the measurements of zeta potential vs different sodium chloride concentrations. As it can be observed, chemically damaged membrane surface is slightly more electronegative than membrane blank. When the damage is physical, membrane surface shows an opposite effect and lower.
